Nucor-Yamato Steel Co.

RE: Surface Corrosion (Rust) on Structural Steel Shapes

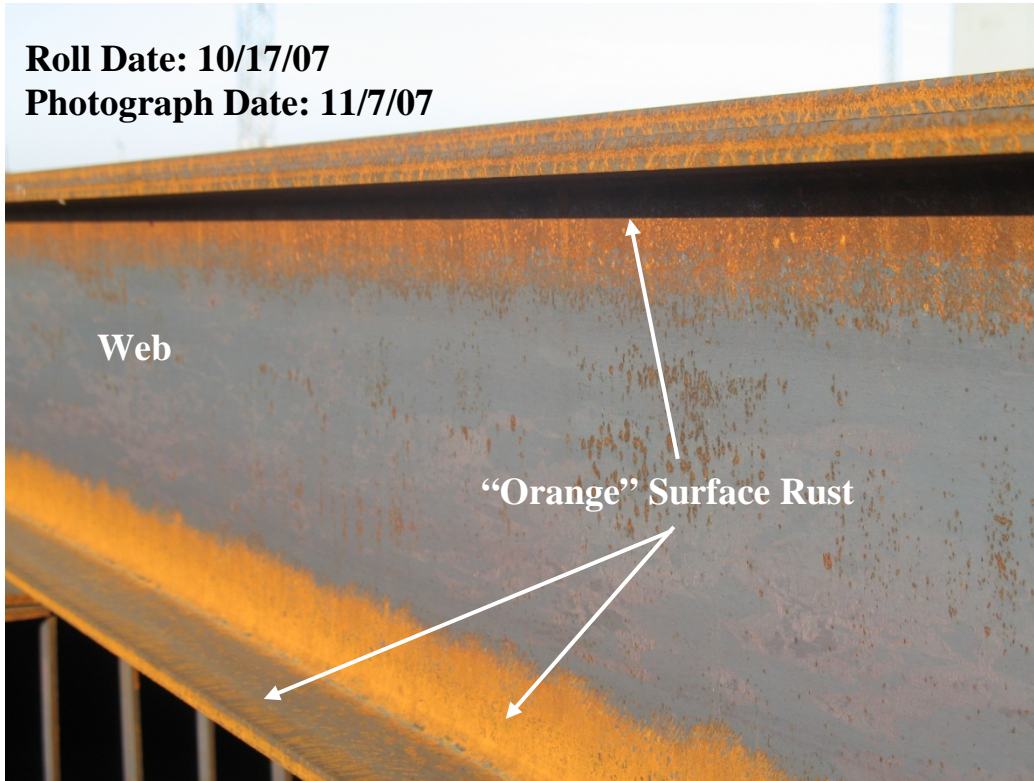
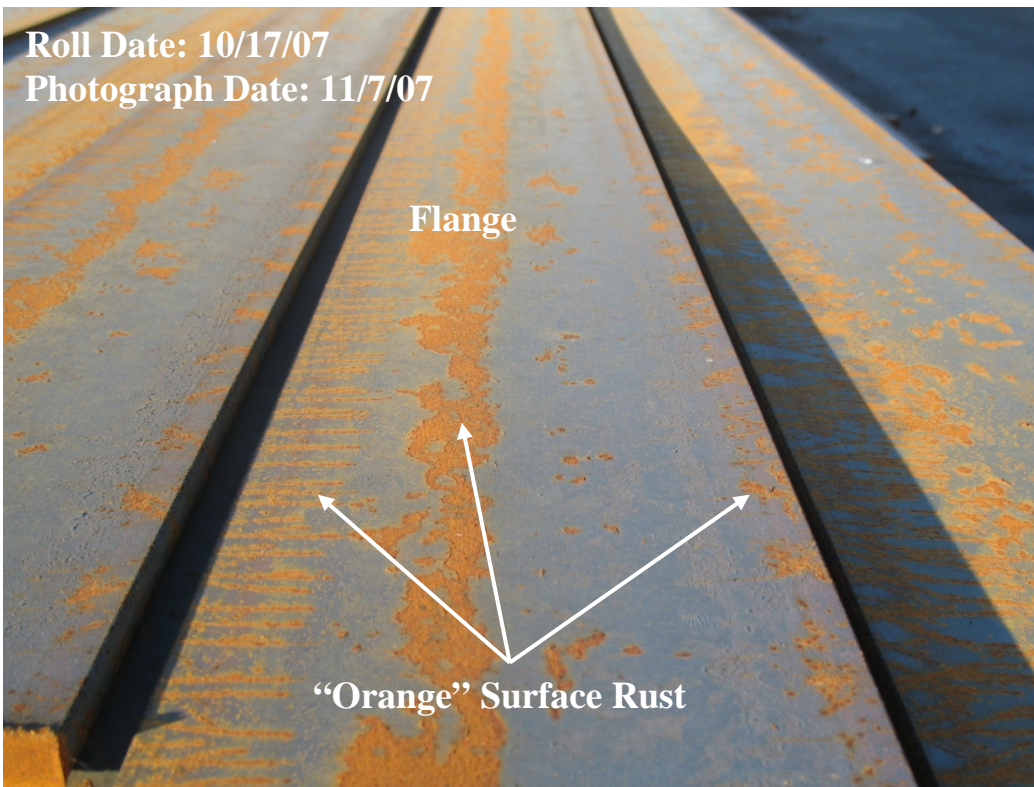
Nucor-Yamato Steel stores the structural steel shapes we produce both inside in one of our warehouses and outside in our yard. Structural steel shapes that are stored outside will begin to form surface corrosion (rust) selectively where the mill scale layer has been removed (see photographs on the next page). This selective corrosion typically occurs on the flanges and the web depending on several production factors. The beams in the photographs were produced on 10/17/07 and stored in one of our outside yards and the photographs were taken on 11/7/07. As the photographs show, there is already an appreciable amount of “orange” surface rust out near the flange toes, on the inside surface of the flanges, and on the web out near the fillet radius after less than one month of being stored in an outside environment.

ASTM A6/A6M, the general requirements specification for rolled structural steel bars, plates, shapes, and sheet piling, states in Section 9.1 Note 5:

Unless otherwise specified, structural products are normally furnished in the as-rolled condition and are subjected to visual inspection by the manufacturer or processor. Non-injurious surface or internal imperfections, or both, may be present in the structural product as delivered and the structural product may require conditioning by the purchaser to improve its appearance or in preparation for welding, coating, or other further operations.
